# STABILUS POWERISE®

## Installation Instruction

**Part Number: 515101**

### Peugeot 5008

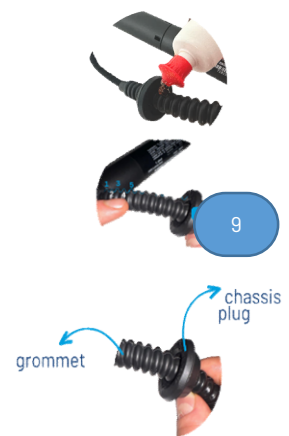
### Step 1: Prepare the grommet

- Apply a drop of dish soap to facilitate plug movement
- Slide the chassis plug onto the 9th rib. Note: Do not count the first two ribs next to the drive
- Adjust the grommet's length by holding the grommet, not the drive
