STABILUS POWERISE®

Installation Instruction

Part Number: 835843

Peugeot 5008

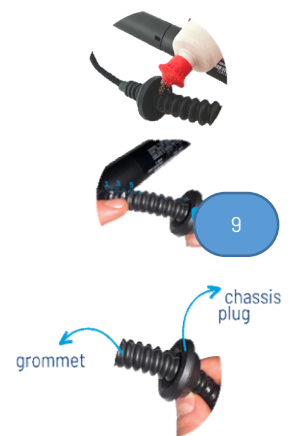
Step 1: Prepare the grommet

- Apply a drop of dish soap to facilitate plug movement
- Slide the chassis plug onto the 9th rib. Note: Do not count the first two ribs next to the drive
- Adjust the grommet's length by holding the grommet, not the drive
